# **Navajo Abandoned Uranium Mine**

## **Site Screen Report**

### **Mexican Cry Mines AUM Site**

**March 2010**

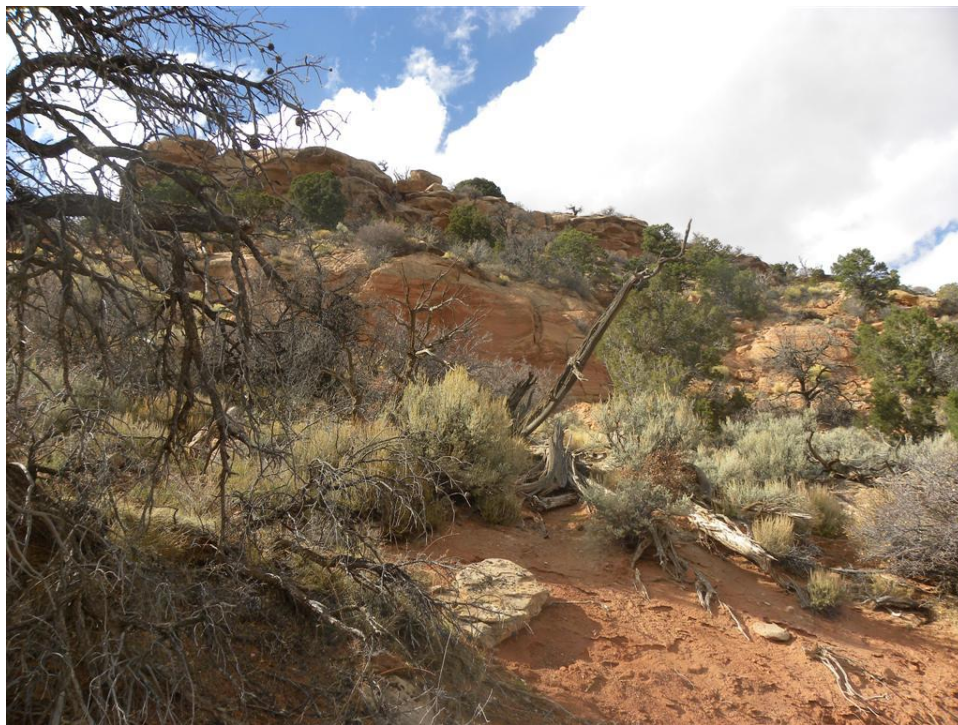
Photo 1. Site #197 – Mine site

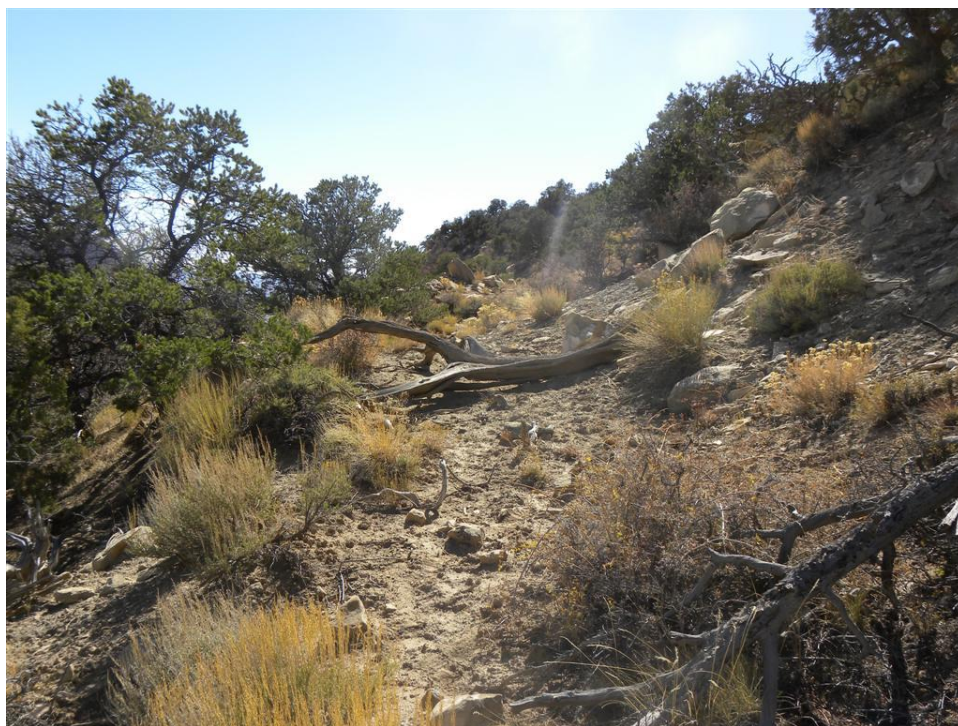
Waste debris extending down inaccessible cliff face, 125' x 25', with a total estimated volume of 579 yd<sup>3</sup>

Photo 2. Site #197 – Mine site and waste rock

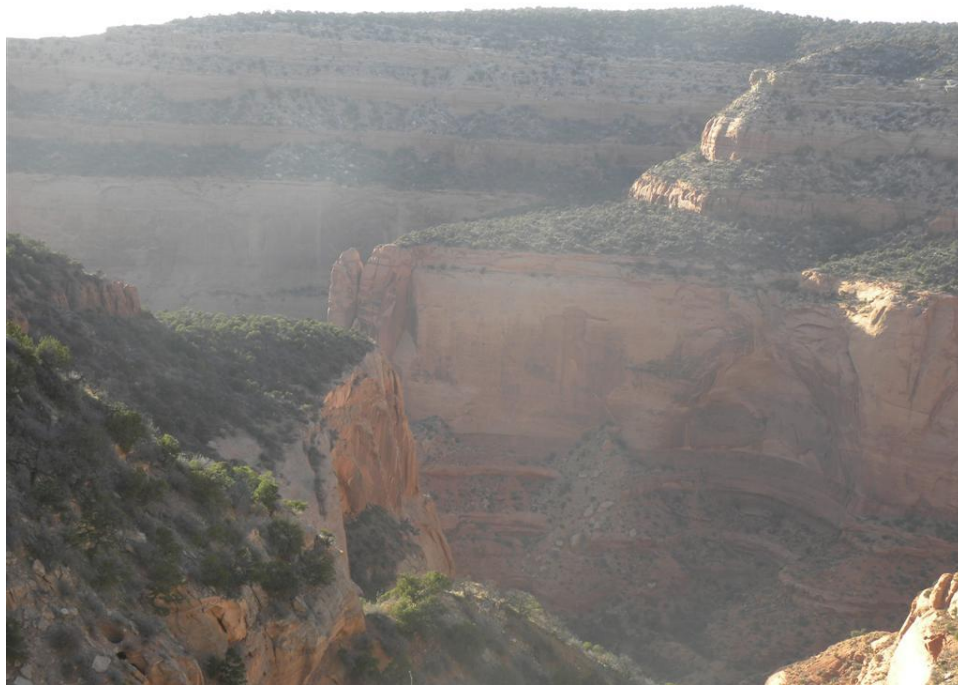
Photo 3. Site #197 – Cliff area and waste debris

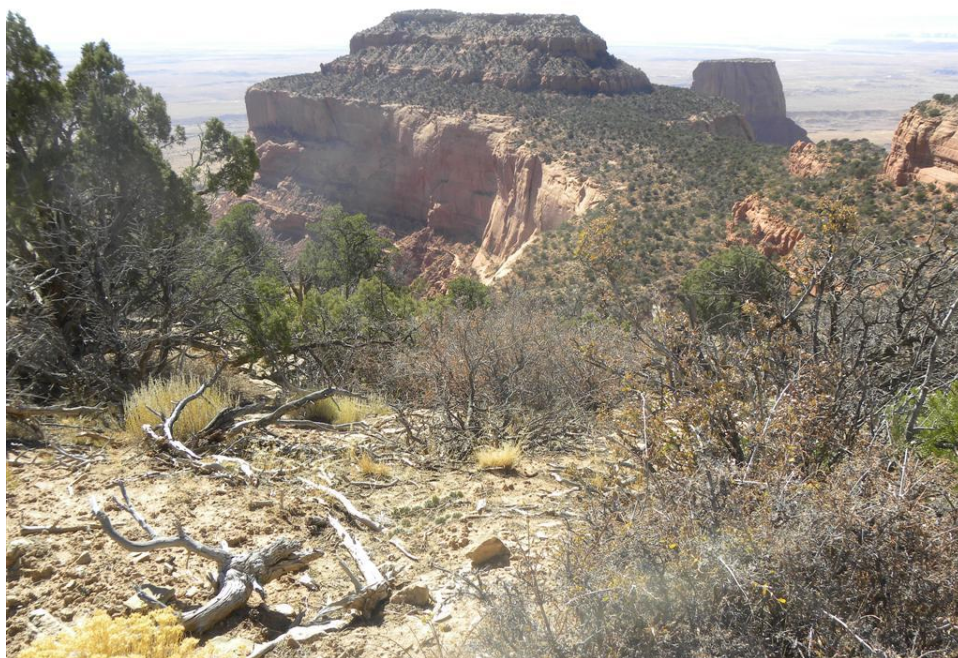
Photo 4. Site #198 – Cliff area

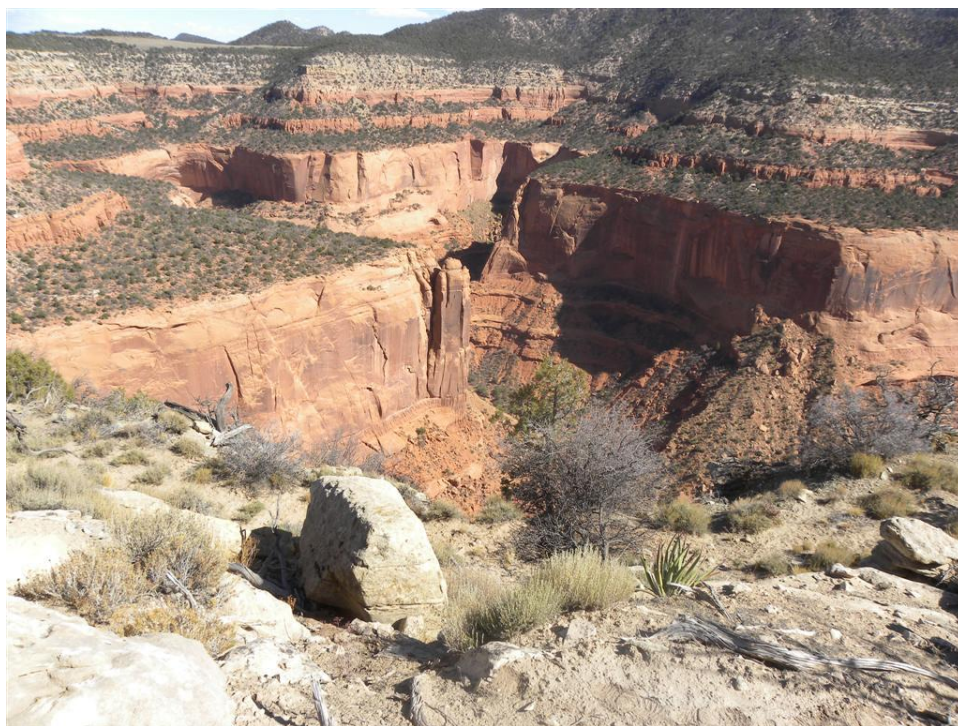
Large waste debris pile cascading down inaccessible cliff face, 250' x 25', with a total estimated volume of 1,157 yd<sup>3</sup>

Photo 5. Site #198 – Cliff area and waste rock
